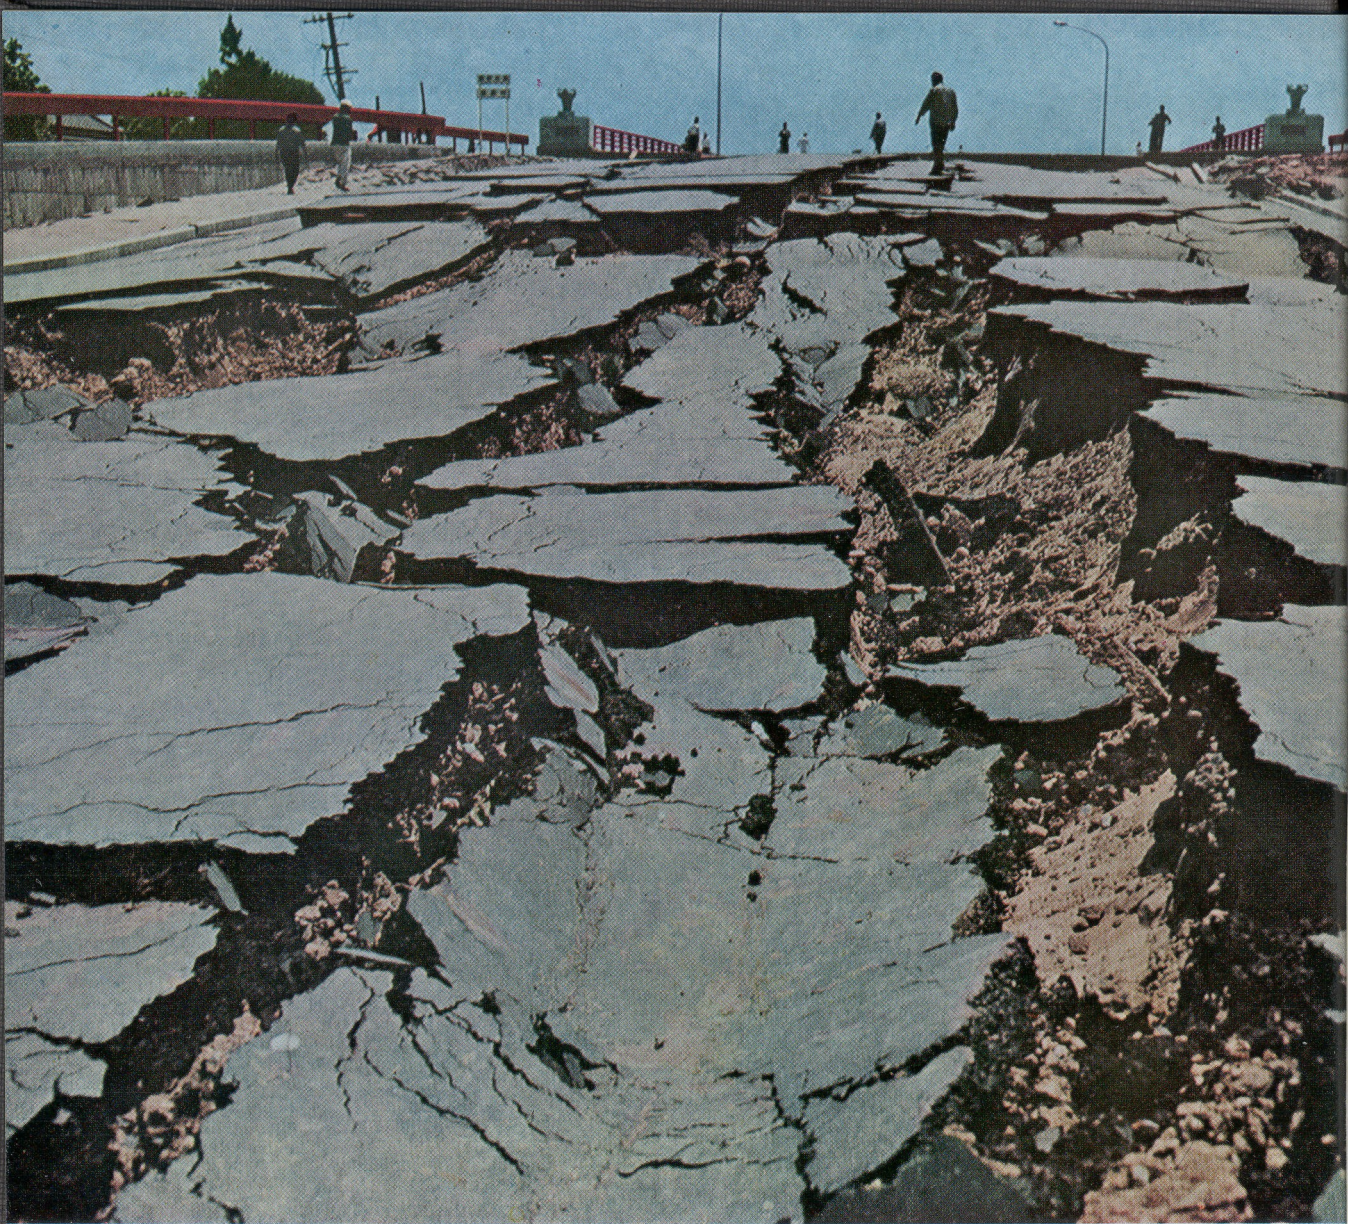
Man-made structures built on reclaimed area or on old river courses suffered great 'ground failure damage' due to the quicksand phenomena. The Shōwa Bridge just completed half a month ago was not only damaged at its approaches but also had two piers broken and five of its twelve girders fallen down into the river Shinano.

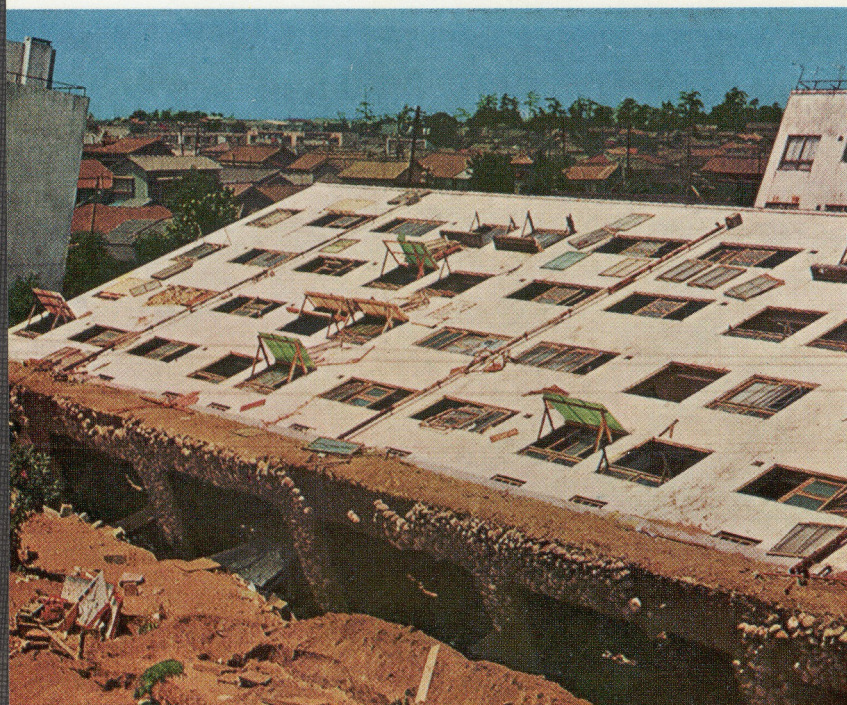
The earthquake vibration was not so strong although severe 'ground failure damage' was caused in the Niigata City. At the premises of this collapsed apartment house the earthquake force was less than twenty percent of the force of gravity according to the strong motion accelerometer record.

This building itself was almost intact without even a hair crack in the walls.
